2011 Site Visit Report

Meadowbank Gold Project

October 3, 2011

Full Report Title: The Nunavut Impact Review Board's 2011 Meadowbank Gold Project Site Visit Report (NIRB File No. 03MN107)

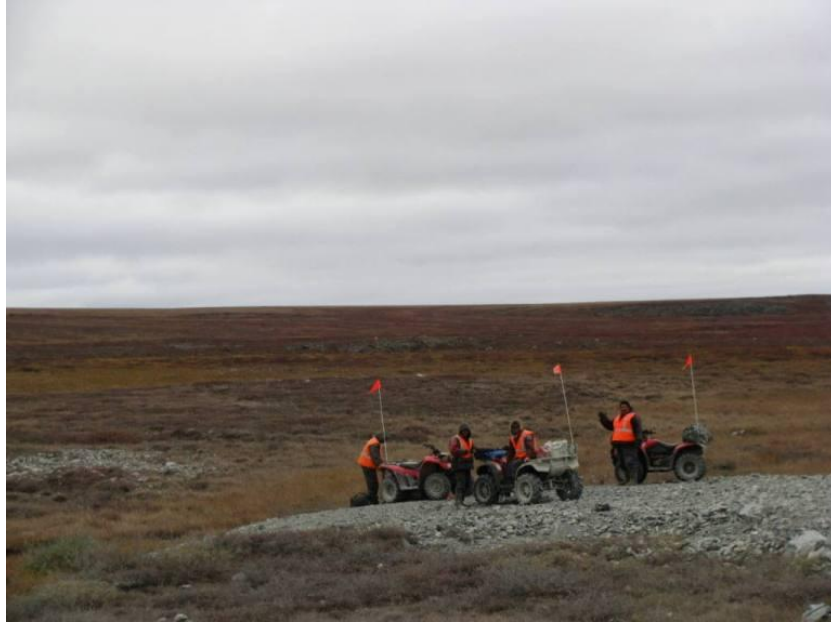
- a.** While being driven from the hamlet of Baker Lake to the Meadowbank site and back by an AEM staff member, few wildlife observations were made. These included white-fronted geese, sand-hill cranes, snow-geese (and blue geese), sik-sik and arctic hare.
- b.** It was noted that during the drive from the hamlet of Baker Lake to the Meadowbank site, an all-terrain vehicle (ATV) travelling southbound with driver was observed near kilometre 80. When returning to Baker Lake from the Meadowbank site. It was observed that a group of travellers were travelling on the land near kilometre 50 and another ATV was observed to be parked on the side of the road near kilometre 45. All travellers had the required buggy whip installed on their ATV's and all users observed wore the safety vests loaned out by AEM (see Photo 1 for example).

Photo 1: Public users of the access road (photo taken 2010; courtesy A. Hanson, NIRB)

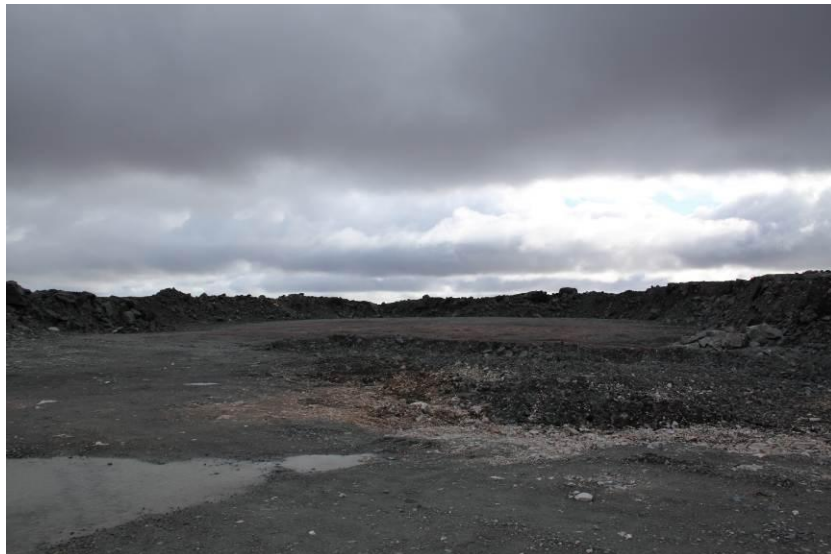
- c. AEM staff advised that all contaminated soil previously stored at Quarry 6 had been moved to Quarry 22. Quarry 22 remains in service as a temporary land farm and storage area for contaminated soils. AEM indicated that it has plans to treat and/or remove contaminated soil. Currently, Quarry 22 is not being used to store other material as in the past (see Photo 2). Mr. Robert mentioned that while AEM may not develop a landfarm, it was considering the development of biopiles (bioremediation method used to reduce concentrations of petroleum constituents in excavated soils¹).

Photo 2: Quarry 22 serving as storage for contaminated soil

The NIRB request to be kept informed of any future plans to develop biopiles as an alternative to landfarms for the treatment of contaminated soil.

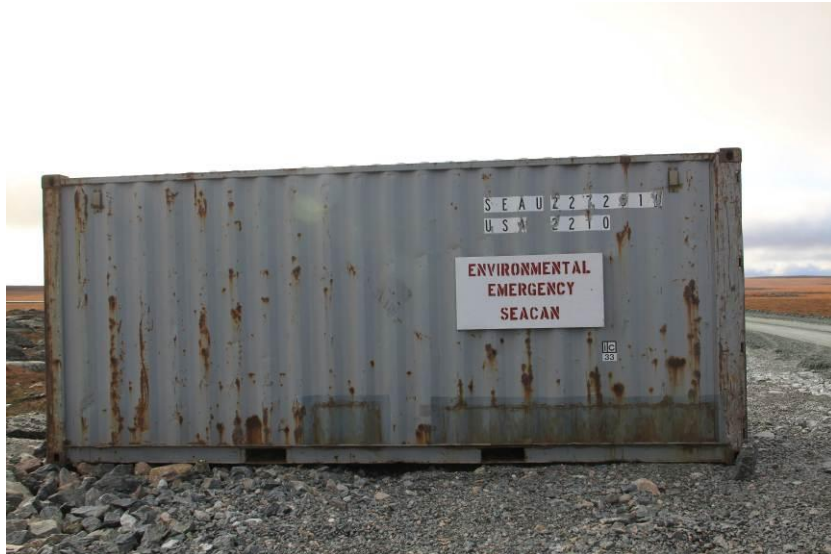
- d. NIRB staff were advised that environmental emergency sea-cans containing booms, shovels, absorbent pads, and other miscellaneous spill response equipment had been placed at every bridge crossing in the event of a spill (Photo 3).

Photo 3: Environmental Emergency Sea-can

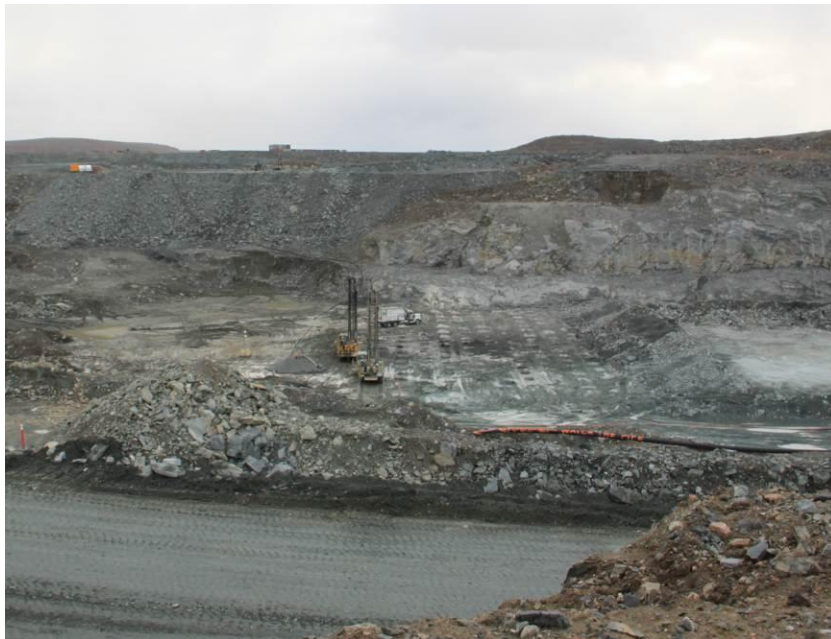
- e. Active blasting and drilling were ongoing at the North and South Portage pits, with daily geotechnical inspections being undertaken to ensure the safety of all employees and contractors working in the active mine area (Photo 4).

Photo 4: Drill equipment works at the South Portage pit

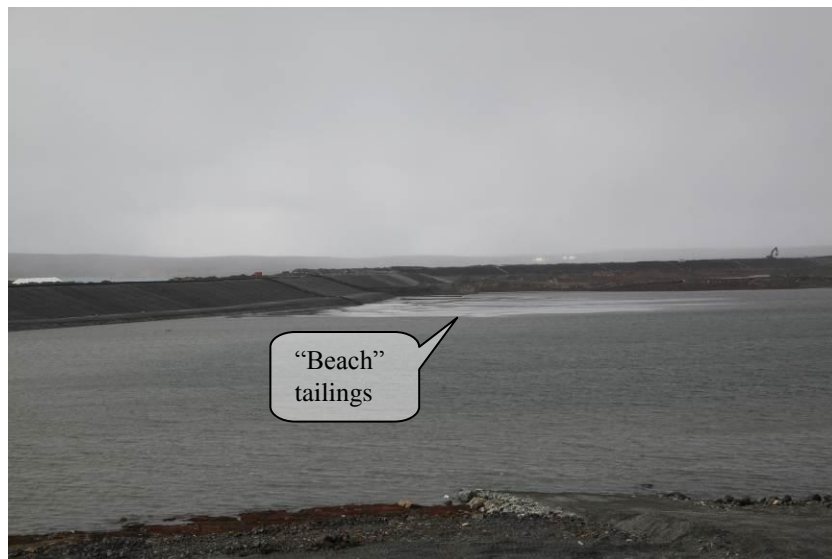
- f. By the end of 2010, approximately 1.6 million cubic metres (m³) of tailings had been placed in the tailings storage facility (TSF) (Photo 5). A structure known as the ‘reclaim barge’ is used to re-circulate water from the TSF back to the mill for reuse within the processing cycle (Photo 6). In addition, Mr. Robert indicated that an internal dike (stormwater dike) is used to prevent leaching of tailings material from the north to the south cell of the TSF. As well, it was noted by Mr. Robert that having a dryer consistency to the tailings deposited within the TSF provides something of a “beach” in the facility which helps to protect the dikes and to prevent ice formation within them. The tailings contain copper and cyanide, and at the time of the 2011 site visit, the TSF contained more water than has been seen in previous years. AEM indicated that the diversion ditch north of the TSF was not completed prior to the freshet season resulting in the additional water and is working on having this diversion ditch completed by fall of 2011.

Photo 5: Tailings storage facility – north cell

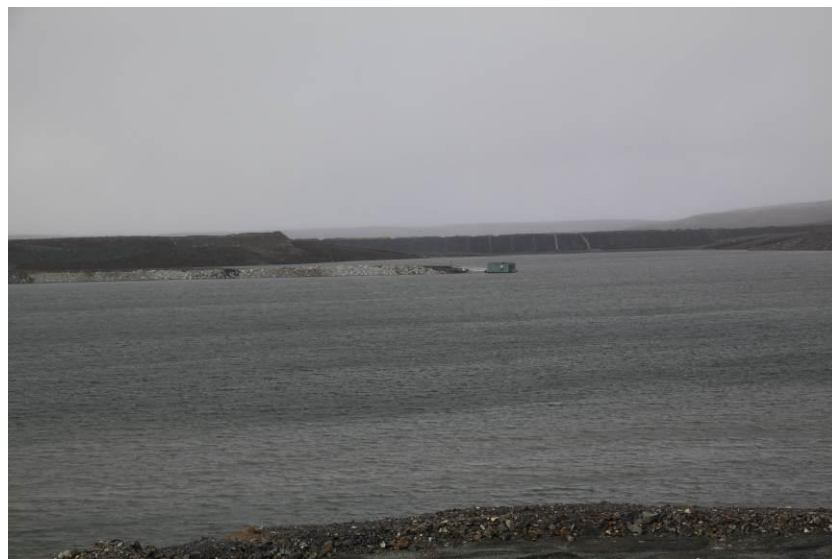
Photo 6: Reclaim barge within the tailings storage facility

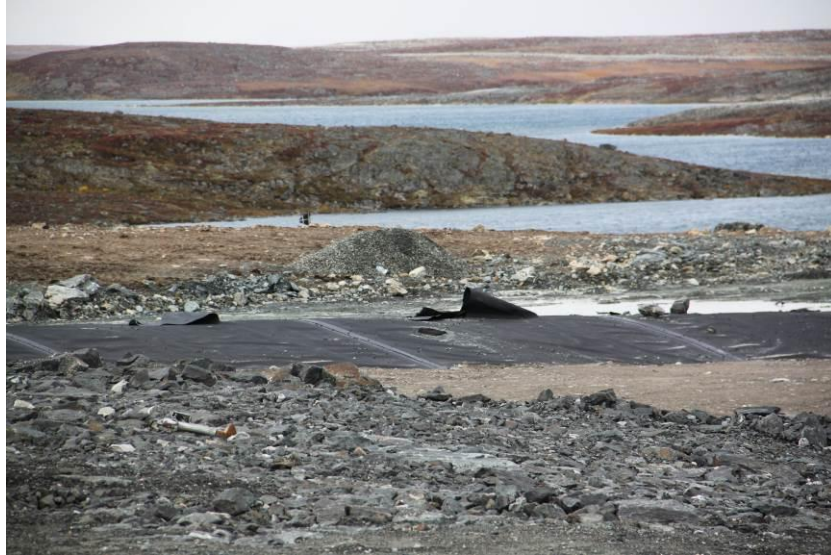
- g. It was noted that the liner for Saddle Dam #1 at the north cell of the TSF was ripped and exposed (Photo 7). Mr. Robert mentioned that the liner would be inspected for tears and that any found would be repaired once Saddle Dam #2 is installed.

Photo 7: Ripped liner at Saddle Dam #1

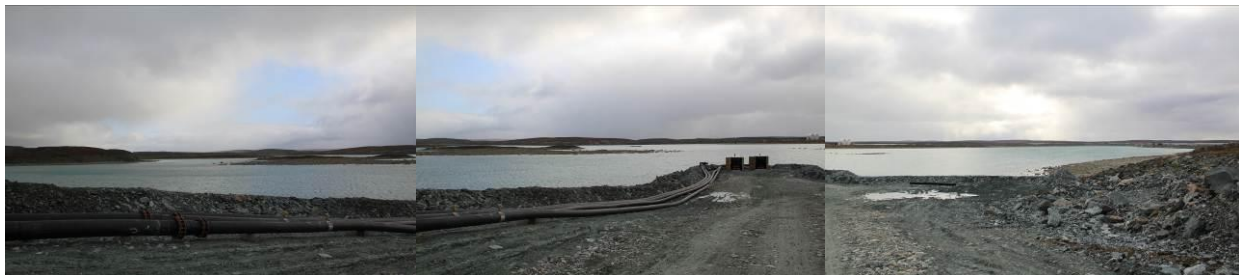
- h. The Bay-Goose dike and causeway was completed in 2010 with the fish out program completed in the summer of 2010. Many of the fish were transferred to Third Portage Lake. During the site visit, it was noted that the Bay-Goose basin was still being dewatered (Photo 8). Water from Bay-Goose basin and South Portage pit are tested for total suspended solids (TSS) to ensure the quality meets discharge criteria prior to release to the environment. Mr. Robert informed the Monitoring Officer that currently, water from the South Portage Pit have been treated at the water treatment facility (Photo 9) prior to discharge while water from the Bay-Goose basin have been discharged directly to the environment. At some point during the dewatering, AEM expects that the water quality from Bay-Goose will not meet the discharge criteria and at that point the water will be diverted to the water treatment facility for treatment prior to discharge.

Photo 8: Bay-Goose basin

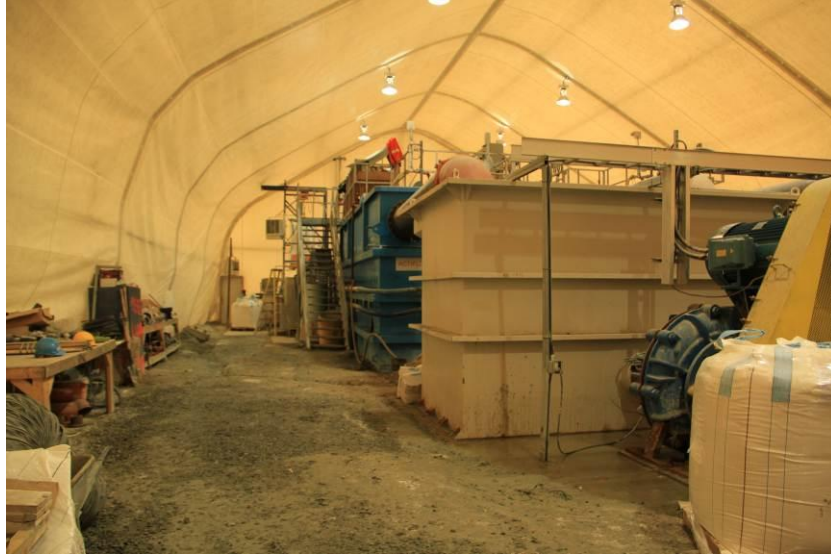
Photo 9: Water treatment facility

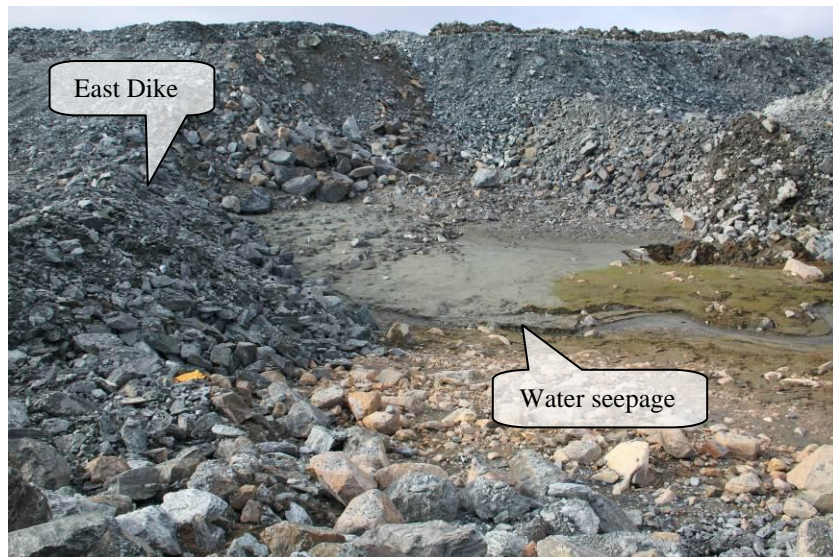
- i. Water is seeping from Second Portage Lake into the Portage pit through the toe of the East Dike at a rate of 1000 m³ per day (Photo 10) from where it is pumped into the TSF. Once the coffer dam is completed, this seepage water will be pumped into the attenuation pond, located south of the actual tailings deposition. AEM is also in the process of submitting plans for future discharge and reclamation of this water.

Photo 10: Seepage of water through East Dike

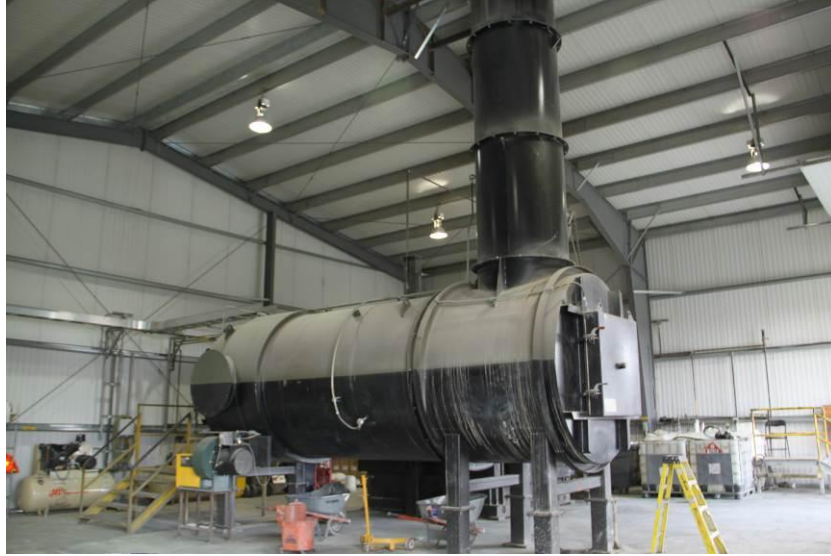
- j. The Meadowbank site dual chamber forced air incinerator remains in service for the combustion of all non-hazardous, combustible materials at the site (Photo 11). Mr. Robert indicated that approximately 1.7 tonnes of domestic garbage is incinerated per day.

Photo 11: Dual chamber forced air incinerator at the Meadowbank site

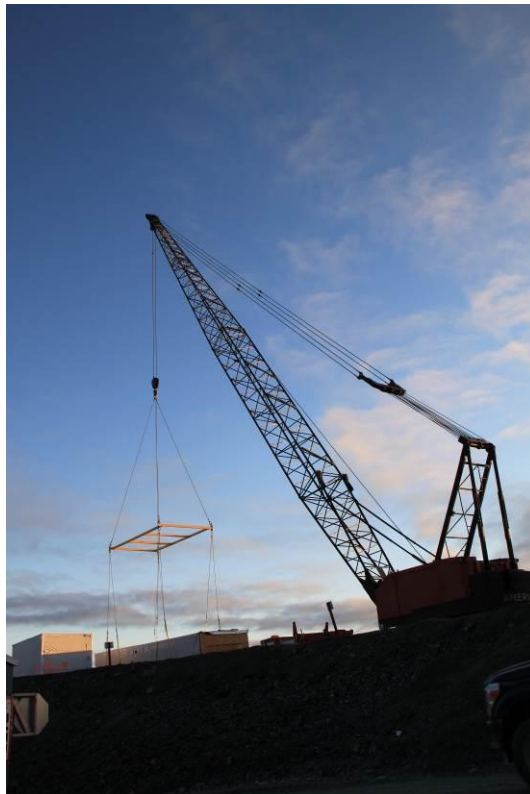
- k. In March 2011, a fire at the Meadowbank mine destroyed the kitchen and dining facilities, certain camp offices and the security office. Mr. Robert advised that a temporary kitchen was brought to site at the end of March and the new kitchen would be operational by December 2011. He further indicated that a separate kitchen space would be provided for Inuit employees to facilitate their preparation of more traditional foods (see Photo 12).

Photo 12: Construction of new kitchen facilities

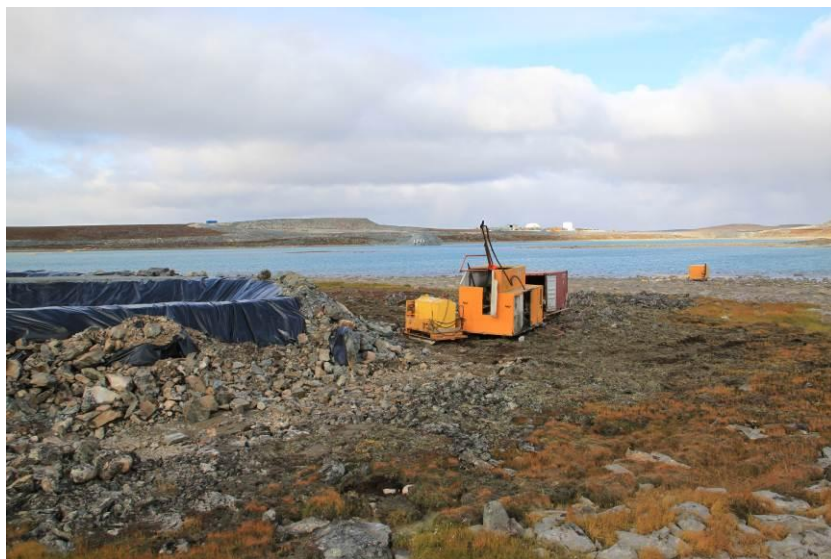
At the time of the site visit, only one groundwater monitoring well was operational. The last of the four groundwater monitoring wells installed in 2003 became damaged from frost action in 2010. Some of these defective wells were replaced in 2006 and two of them were again replaced in 2008 with a more robust design. Mr. Robert indicated that AEM was drilling a new well at Bay Goose area (Photo 13) and that a second well would be added under the TSF.

Photo 13: Drilling of groundwater well at Bay Goose area

Regarding Condition 8, the Proponent has indicated that two new groundwater wells are to be installed in the future. The Monitoring Officer notes that during the 2010 groundwater monitoring program, only one well remained operational and functioning to collect data compared to the original four installed in 2003.

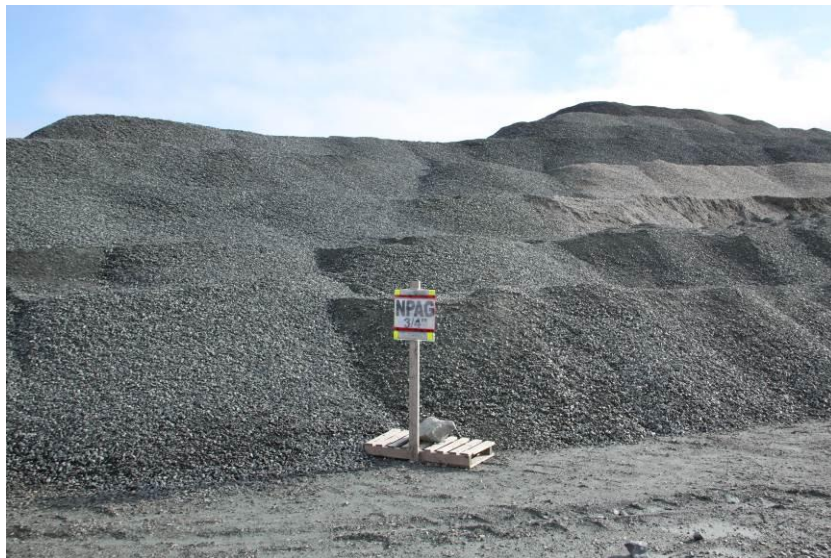
Mr. Robert indicated that AEM samples every single blast hole and conducts an on-site analysis of the percentages of sulphur and carbon present in these samples. These results are used to differentiate between non-potentially acid generating (NPAG) and potentially acid generating (PAG) materials and to differentiate both of these from ore material. This information is then

used by mine surveyors and geologists to delineate the dig limits within the blasted rock and to guide the shovel and loader operators in directing where the rock is to be taken. Most of the NPAG material (see Photo 14) have been used to construct the dikes, dams, roads, and pads at site, while the PAG rock have been used in the TSF, stormwater dike, and rockfill road. Any remaining PAG rock material is sent to the Portage waste rock facility.

Photo 14: NPAG waste rock material

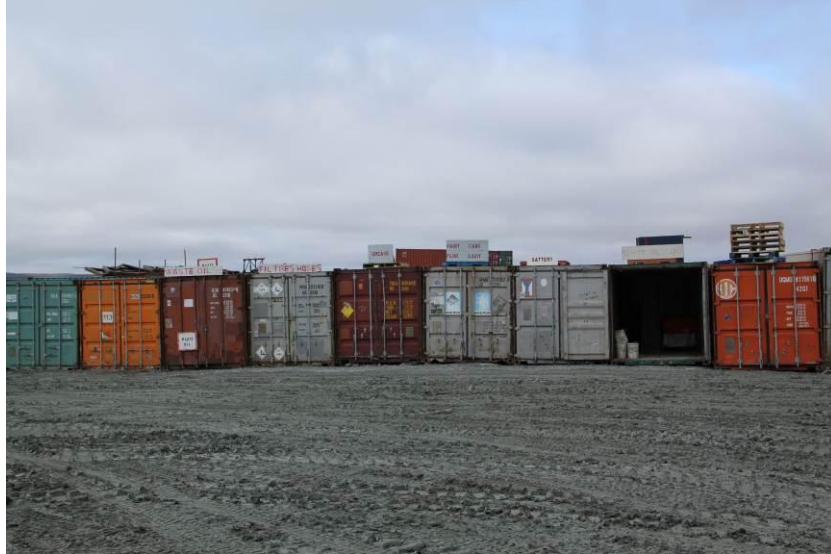
During the 2011 site visit, AEM appeared to be segregating and storing all domestic, hazardous, and combustible wastes in marked sea-cans prior to being incinerated or shipped to appropriate and approved off-site disposal facilities (Photo 15). Sea-cans filled with waste are backhauled via truck haul to Baker Lake and then with the annual sea lift to southern Canada.

Photo 15: Sea-cans used for waste segregation and storage area

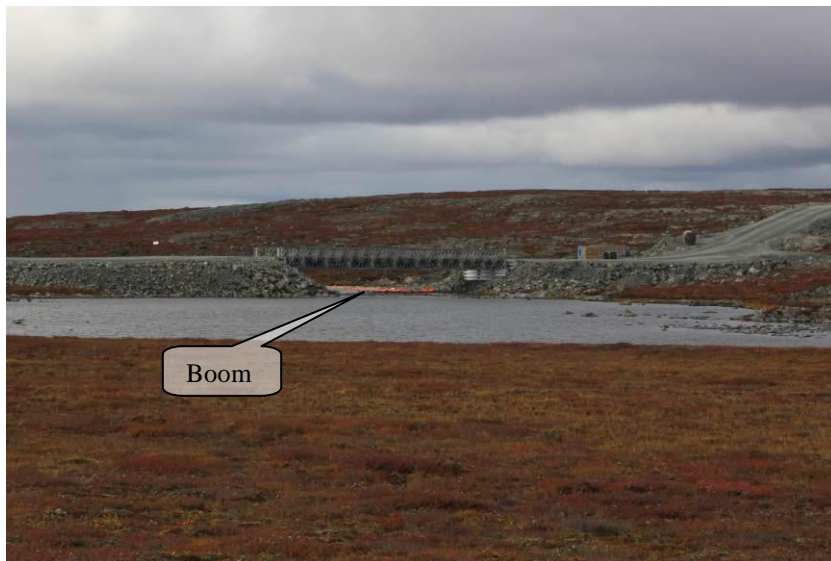
NIRB staff were advised that follow up action is still to occur for the 3,000 litre (L) fuel spill that occurred near kilometre 22 of the access road in October 2010. AEM indicated that booms deployed in the watercourse nearby are checked weekly and changed when needed (see Photo 16 and Photo 17) to ensure that contaminated water does not enter the water body. The contaminated soil (approximately 5,050 tons) was taken to Quarry 5 and will remain there until a management plan is developed and implemented that addresses the issue of the contaminated soil (see Photo 18). In addition, Mr. Robert indicated that follow up action will be completed in the spring of 2012 for this spill site. No fuel contamination or staining of the water was noted by the Monitoring Officer; however, a strong hydrocarbon odour was noticeable at the spill site.

Photo 16: Bridge near kilometre 22 (HADD bridge)

Condition 26 requires that spills be cleaned up immediately and that the site be kept clean of debris. The Monitoring Officer notes that the fuel spill near kilometre 22 was still being treated and through discussion with AEM, that follow-up action would be continued in the spring of

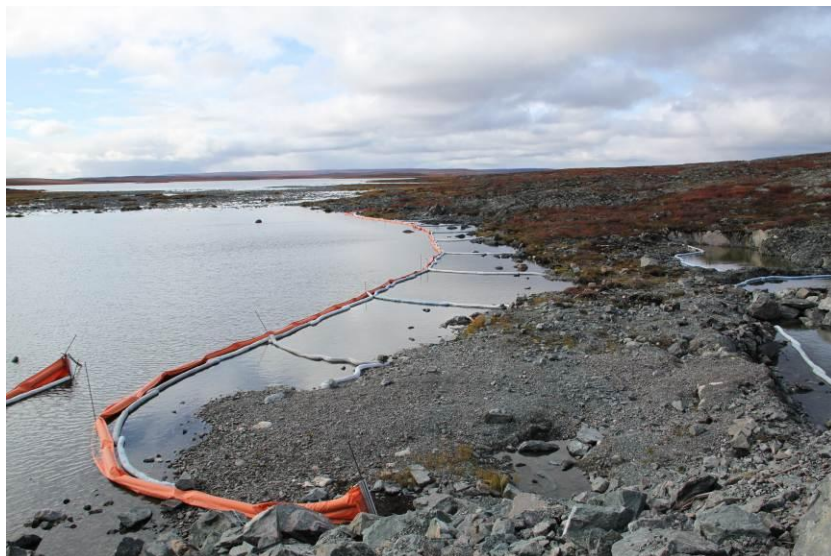
Photo 17: Booms and screens in place at HADD bridge to prevent any fuel from entering stream

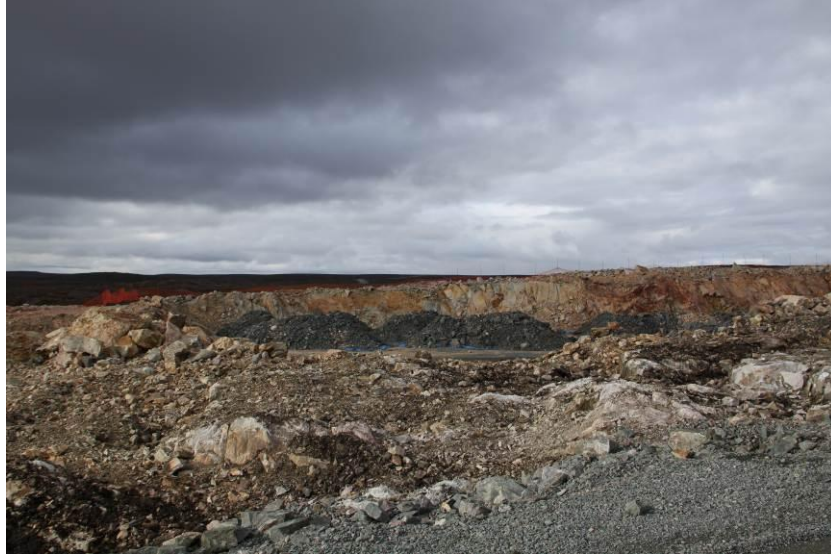
Photo 18: Quarry 5 containing contaminated soil from fuel spill at kilometre 22

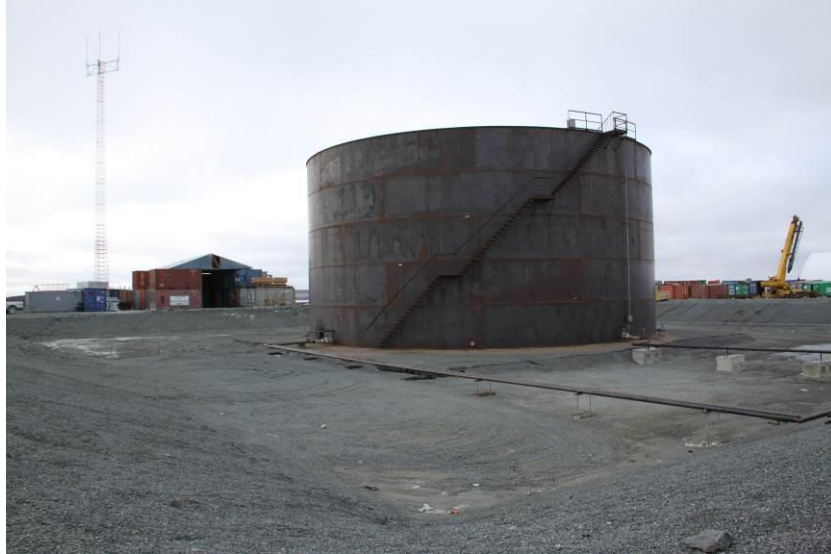
During the 2011 site visit, the Monitoring Officer observed that all of AEM’s fuel and hazardous materials associated with the Meadowbank project appeared to be stored in a safe and environmentally protective manner (i.e. secondary containment at fuel storage areas and secure containment of hazardous materials; see Photo 19). The fuel transfer station on site appeared to be well contained and properly set up for the fuelling of vehicles (Photo 20). Hydrocarbon odours were noted at the on-site fuel tank farm and at the HADD bridge at kilometre 22, and further, the Monitoring Officer noted that the liner at the on-site fuel tank farm was exposed.

Photo 19: Meadowbank on-site fuel tank farm

Condition 27 requires that the Proponent use safe, environmentally protective methods for areas used to store fuel or hazardous materials. The Monitoring Officer noted that the liner at the on-site fuel tank farm was exposed.

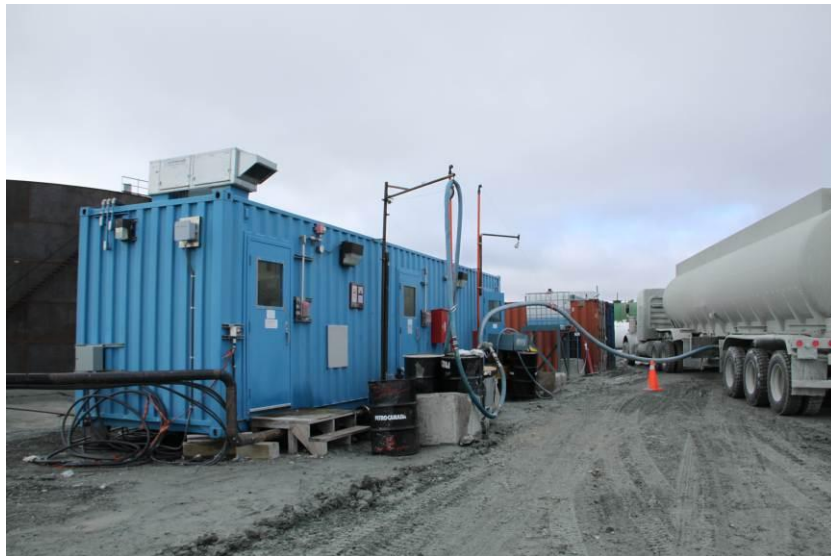
Photo 20: Meadowbank fuel transfer station

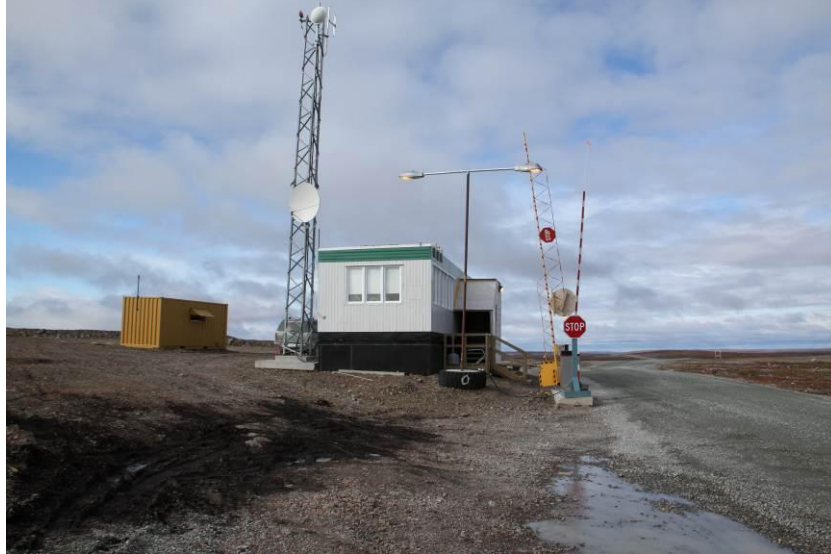
AEM maintains one gatehouse at kilometre 5 of the access road, and another gatehouse close to the entrance to the mine site and camp at Meadowbank. Both gatehouses are manned by guards who monitor the safety and security of all personnel using the road. All traffic is required to check in (via radio or in person) with the employee at the gatehouse prior to proceeding past either gatehouse (see Photo 21).

Photo 21: Gatehouse at kilometre 5, near Baker Lake

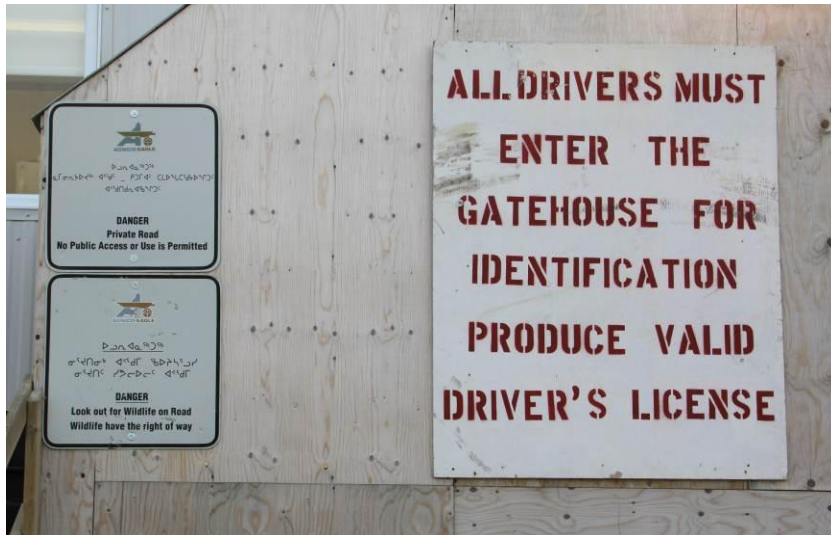
The Monitoring Officer noted that the required signs as per Condition 32(d) were located at the gatehouse (Photo 22) and at 10 kilometre intervals along of the road (see Photo 23 for examples). The signs were posted in both English and Inuktitut and were placed on the sides of the emergency sea-cans which were located every 10 kilometres along the road. AEM indicated that previous free-standing sign posts had been damaged during the winter season. No signs were noted at bridge crossings.

Photo 22: Signs posted at gatehouse at kilometre 5

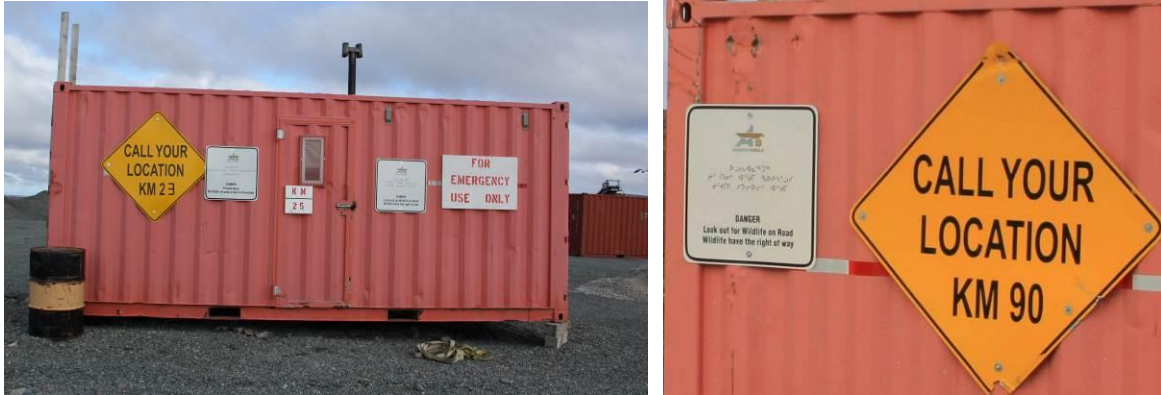
Photo 23: Signs posted at kilometre 25 and kilometre 88

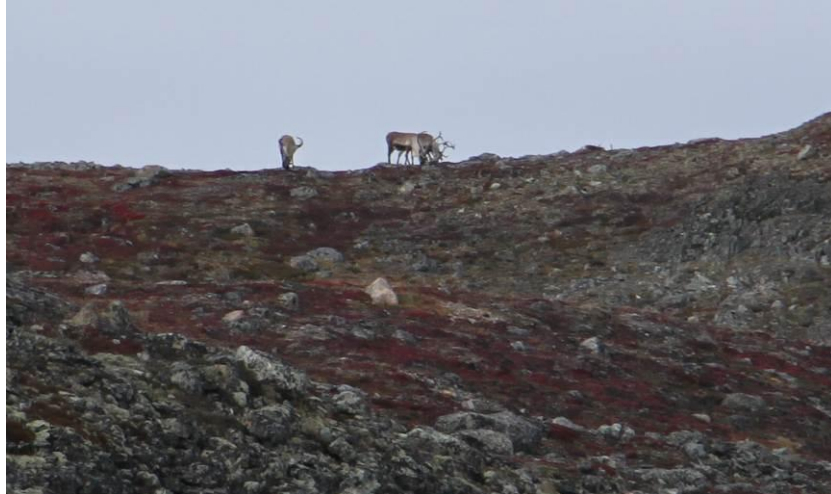
Caribou were observed on an island near the freshwater barge (Photo 24). In addition, Canada Geese were observed in and near the TSF (Photo 25). Mr. Robert indicated that birds had been observed in and around the TSF, especially during the spring months. Mr. Robert noted that deterrents are used to keep wildlife including birds away from the facility. No other wildlife were observed around site except Snow Geese.

Photo 24: Caribou near freshwater barge

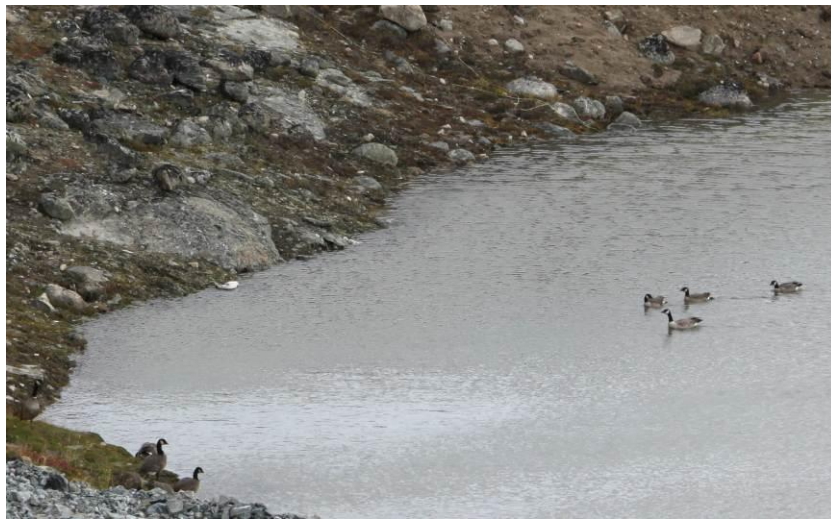
It was noted during the site visit that no deterrents had been established near the TSF (per Condition 59). Discussions with Mr. Robert indicated that geese had been landing in the open water of the TSF and subsequently, that AEM had attempted to deter the geese. No caribou have been observed by the environment department in or near the tailings facility. The Monitoring Officer also noted that the TSF is bounded on all sides by active mine site roads.

Photo 25: Canada Geese at the tailings storage facility

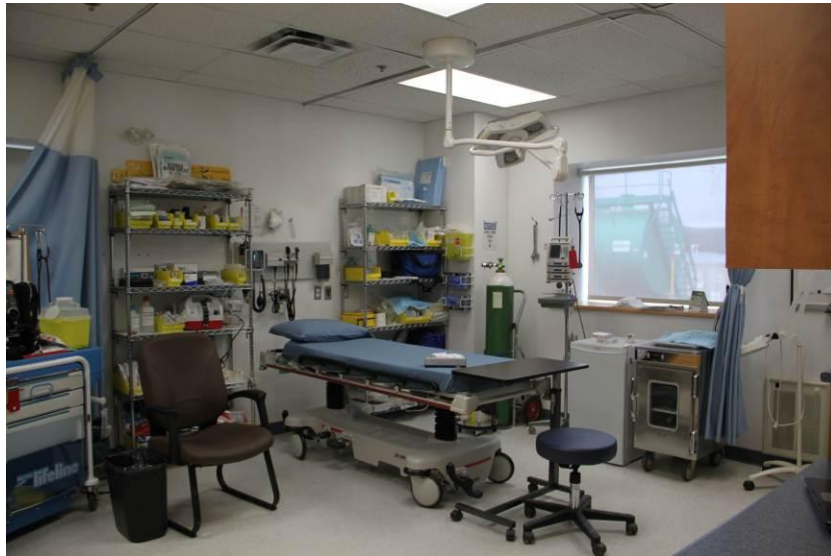
During the 2010 site visit, AEM had established a temporary nursing station that had been housed in a camper-style site response vehicle, while the permanent nursing station was being completed. During this site visit, the Monitoring Officer was able to visit the new permanent nursing station established at site (Photo 26). Usually, AEM has two nurses at site at the same time.

Photo 26: Permanent nursing station at the Meadowbank site

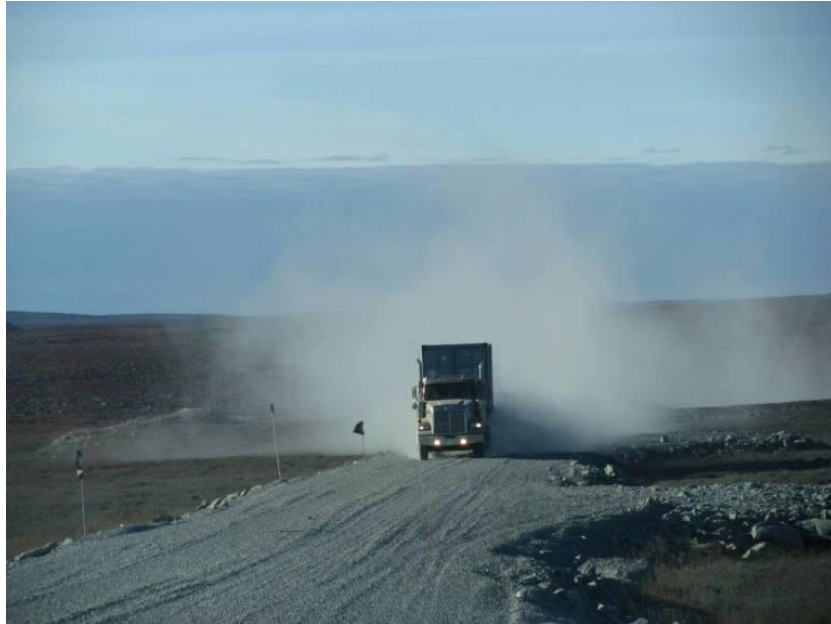
Water is administered onto the roads around the Meadowbank site as a dust suppressant. The Monitoring Officer noted however, that no dust suppression was employed along the access road. Mr. Robert indicated that due to the logistical requirements and other feasibility issues, the use of dust suppressant has not been initiated along the access road (Photo 27).

Photo 27: Semi-truck hauls empty sea-cans from Meadowbank to Baker Lake (photo taken 2010; courtesy A. Hanson, NIRB)

The Proponent does not appear to have fully met the requirements of Condition 74, as dust suppression techniques while applied at the Meadowbank site, have not been applied to the access road.

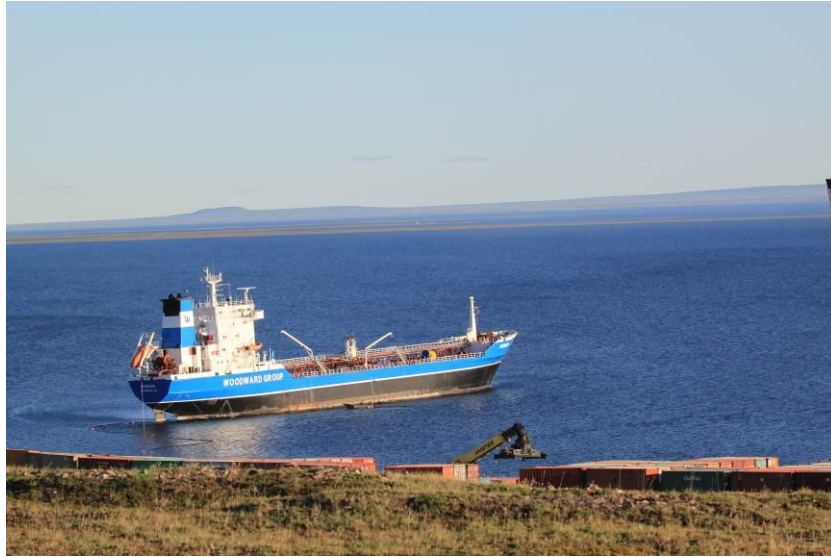
Photo 28: Barge offloading cargo at Baker Lake barge laydown facility (photo taken July 28, 2011)

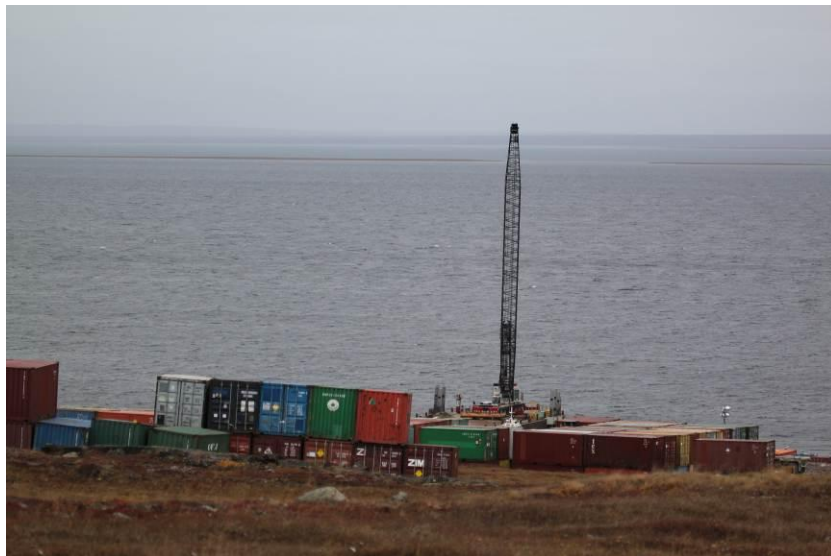
The Monitoring Officer did note that these areas were kept impressively clean with sea-cans well organized during the barge season (see Photo 29 through Photo 31).

Photo 29: Baker Lake laydown facility (photo taken September 17, 2011)

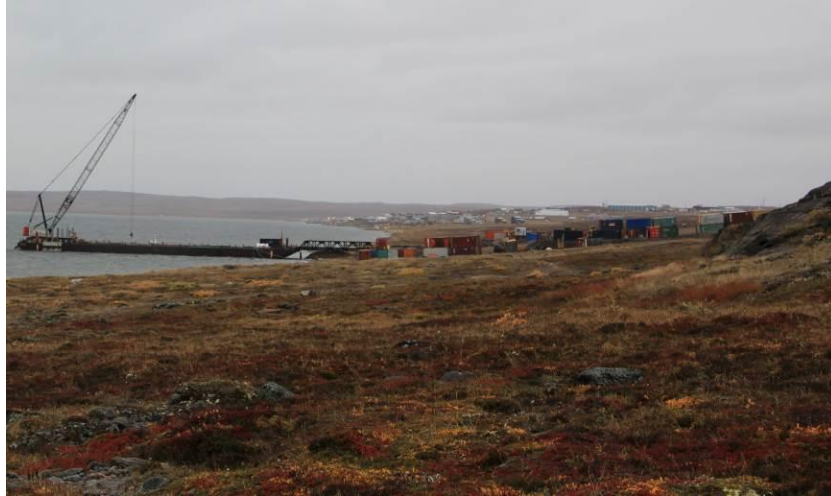
Photo 30: Baker Lake barge laydown facility (photo taken September 17, 2011)

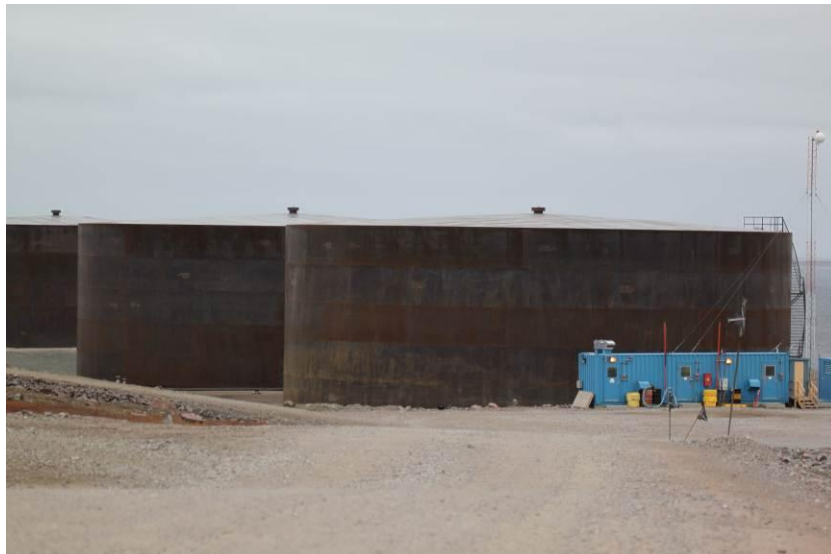
During unofficial visits to AEM’s Baker Lake fuel tank farm and barge laydown facility, the Monitoring Officer did not observe any notable security measures in place at these sites (see Photo 28 through Photo 31). During the 2011 Site Visit, Mr. Robert indicated that all hazardous and explosive components received at the marshalling and storage area are shipped immediately to site and further, that during the sealift period, AEM ensures that 24 hour security, including surveillance cameras, are put into place.

Photo 31: Baker Lake fuel tank farm (photo taken September 17, 2011)

As noted in the 2010 site visit and monitoring reports, and as was observed again during the 2011 site visit, no security measures were in place at the Baker Lake storage and marshalling area as required by Condition 81.
